Environmental Monitoring Report

Project Number: 42145

January-June 2025

Armenia: North-South Road Corridor Investment Program (Tranche 1 and 2)

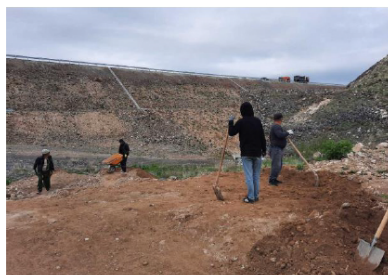
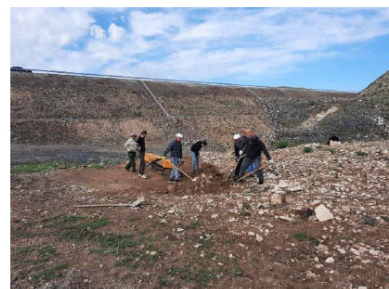
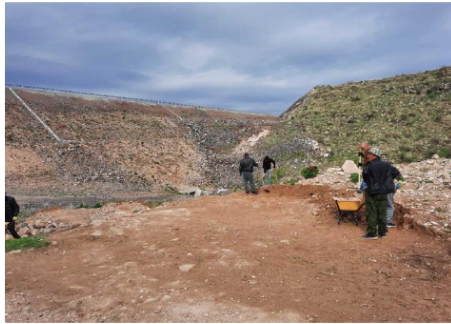
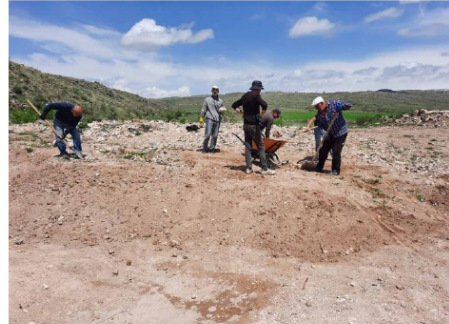
On April 14, 2025, in accordance with the agreement reached between the Institute of Archaeology and Ethnography of the NAS RA, the final cleaning works of the Nerkin Sasnashen Archaeological Complex started. At the end of July 2024, large stone fragments were removed from this site using machinery, and now final cleaning of the area of the site has been carried out. The archaeological complex here has suffered significantly from the previously filled soil and rock debris. The site was cleaned only with hand tools, and the accumulated soil and rock debris were removed as much as possible. Partially preserved parts of the structure can now be seen in the area. With this cleaning stage, the site can be considered freed from soil and rock waste (Images 1-8).

Images 1-4 Final cleaning works of the Nerkin Sasnashen Archaeological Complex

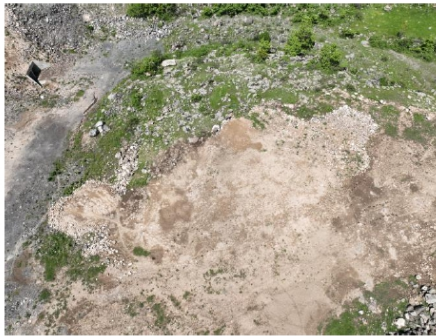
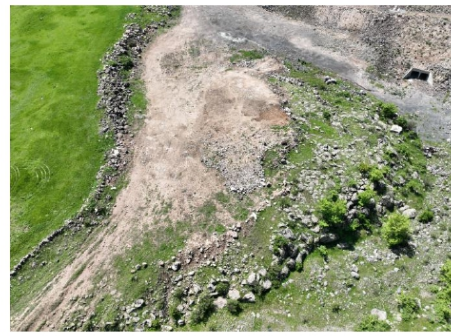
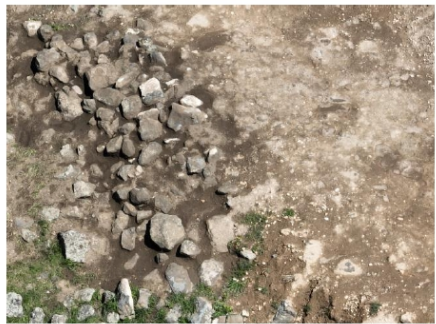
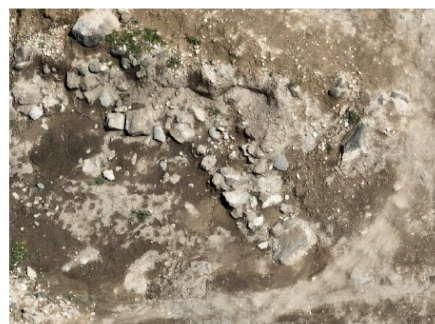
Նկարներ 5-8. Օդալուսանկարներ մաքրված տեղամասից
Images 5-8: Aerial photos of the cleared area

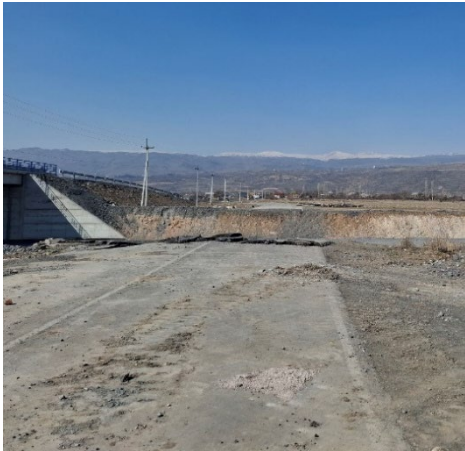
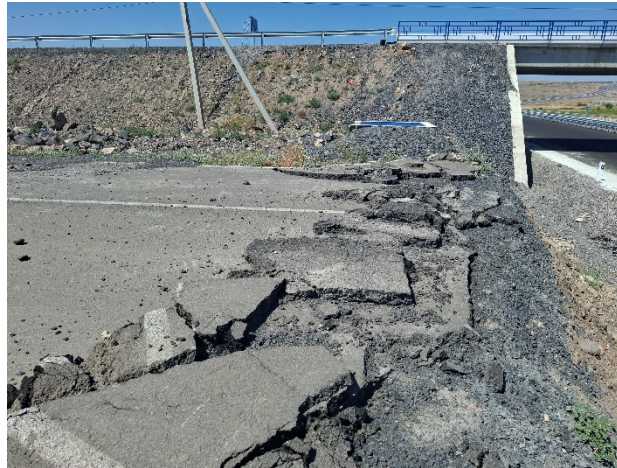
TASK 1			
Issue/Observation	Photos	As of 31 June, 2025	Photos as of 27.06.2025
<p>1. ABANDONED ASPHALT ROAD</p> <p>During the construction phase in the Voskevaz section, the Contractor built a temporary bypass road, part of which crosses private land. This bypass road is no longer needed and has been left abandoned. Additionally, there is asphalt debris in the area, resulting both from the construction works and the partial dismantling of the bypass road.</p>

<p>STATUS: PENDING</p> <p>Corrective Actions:</p> <p>1) Engage in discussions with the private landowner to reach an agreement on the continued presence of the bypass road on their property.</p> <p>2) Remove all asphalt waste and construction debris from the area to ensure environmental cleanliness.</p> <p>Resolution deadline: 15.07.2025</p>

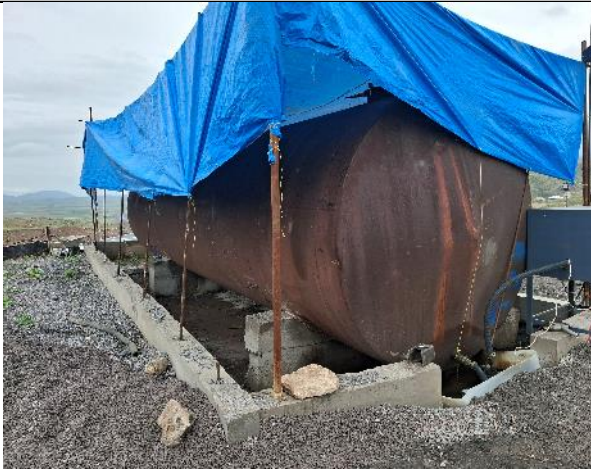
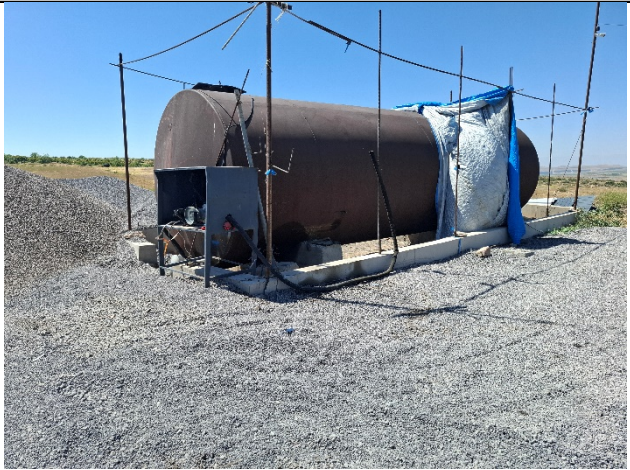
Issue/Observation	Photos	As of 31 June, 2025	Photos as of 27.06.2025
<p>6. Secondary Containment for the fuel tank: The fuel tank should be provided with secondary containment with the volume of 110% from the volume of the tank as well as covered.</p>

<p>STATUS: PENDING</p> <p>THE COVER OF THE DIESEL TANKER WAS BLOWN OFF BY THE WIND.</p> <p>Resolution deadline: 15.07.2025</p>

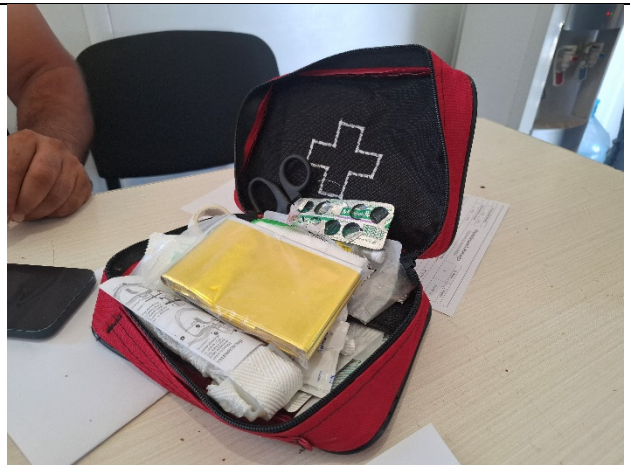
<p>7. First Aid Kit The first aid kit does not have enough necessary medicines.</p>		<p>NO ISSUES WERE OBSERVED HERE</p> <p>The issue requires ongoing monitoring and will remain a focus for the consultant during the next visits.</p>

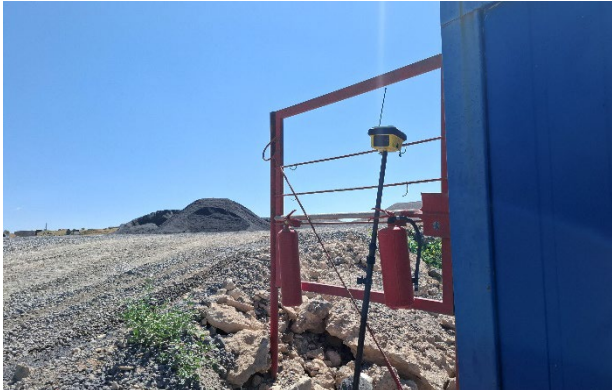
Issue/Observation	Photos	As of 31 June, 2025	Photos as of 27.06.2025
<p>8. Fire Extinguisher: Proper fire extinguishers should be readily available at the project site. Proper monitoring of fire extinguishers should be conducted regularly, and any units found to be out of order should be promptly replaced.</p>		<p>NO ISSUES WERE OBSERVED HERE The issue requires ongoing monitoring and will remain a focus for the consultant during the next visits.</p>

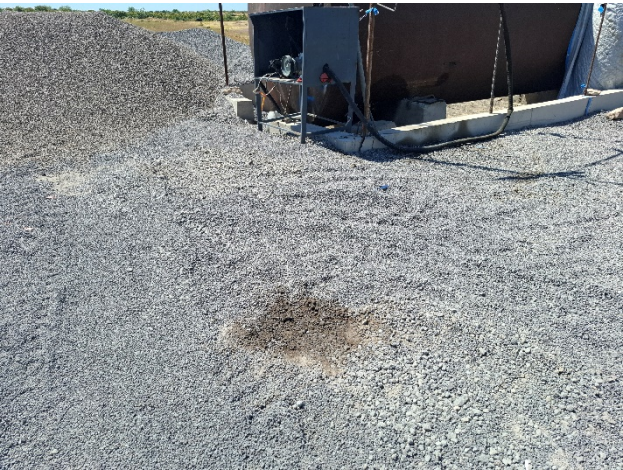
<p>9. Fuel Leak at the Camp site During the visit traces of fuel leakage at the camp were observed. Contaminated gravel must be replaced and proper storage should be provided.</p>	 	<p>STATUS: PENDING Contractor is replacing polluted material from time to time. The issue requires ongoing monitoring and will remain a focus for the consultant during the next visits. The Contractor is instructed to refresh the gravel on a weekly basis. Resolution deadline: 15.07.2025</p>

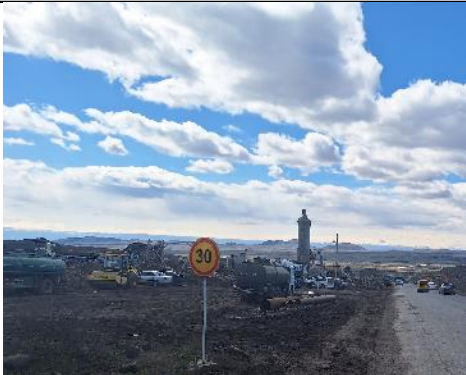
Issue/Observation	Photos	As of 31 June, 2025	Photos as of 27.06.2025
<p>10. Main road exits Exits to the main road are not filled with crushed stone.</p> <p>All exits must be equipped with a stop sign.</p>

<p>NO CONCERNS WERE OBSERVED HERE</p> <p>The issue requires ongoing monitoring and will remain a focus for the consultant during the next visits.</p>	
<p>11. Sanitary Conditions Properly operated toilet and hand-wash facilities should be provided at the CAMP</p>

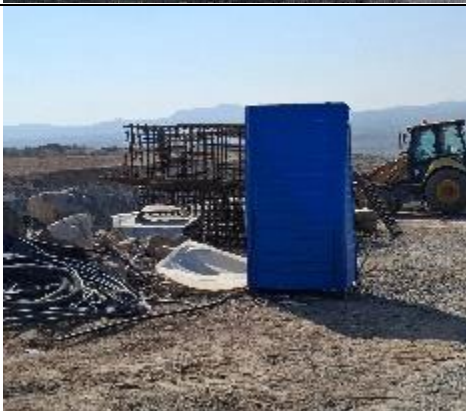
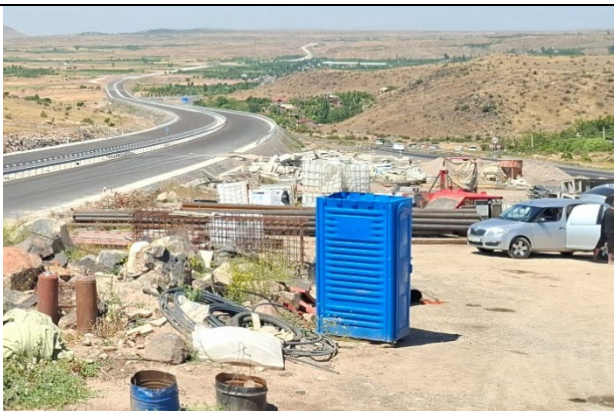
<p>STATUS: PENDING</p> <p>As of the site visit date, existing toilet still there.</p> <p>The technical condition of the toilet remains poor; it is recommended to consider replacing it.</p>

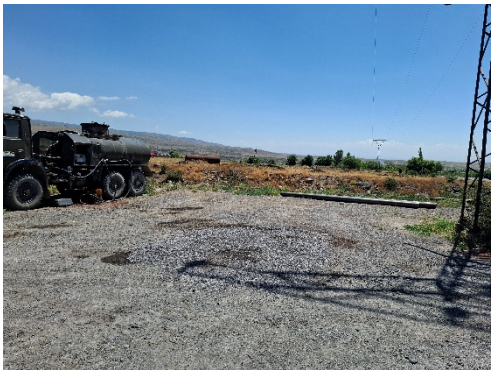
TASK 2		
Issue/Observation	Photos	UPDATE as of 27.06.25
<p>1. Fuel Leak at the Camp site</p> <p>During the visit traces of fuel leakage at the camp were observed.</p>

<p>Fuel leaks were observed during the visit.</p> <p>Contaminated gravel must be replaced and proper storage should be provided.</p> <p>The deadline to resolve the issue: July 15, 2025</p>
<p>2. Vibration Assessment</p> <p>During the ADB mission visit on October 14 2024, the Environmental Specialist from ADB, Armine Yedigaryan, requested the implementation of the same vibration mitigation measures used in the ADB-financed M6 Project. During the visit on April 16, 2025 the ADB's position was reconfirmed.</p>	<p>NO PHOTO</p>	<p>The issue is still pending.</p> <p>The issue is under discussions with RD, the Engineer and the Contractor.</p>

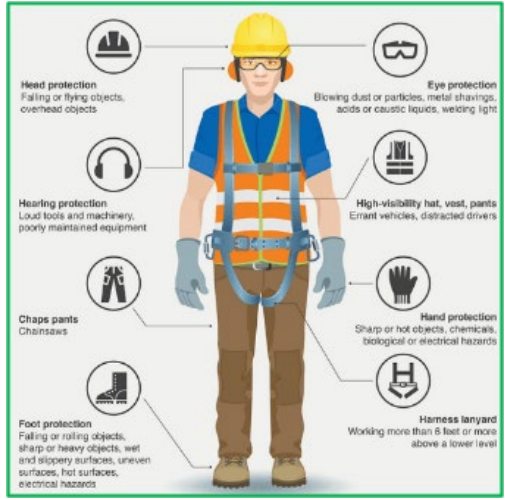
TASK 2		
Issue/Observation	Photos	UPDATE as of 27.06.25
<p>3. PPE</p> <p>Workers are performing tasks at height without using the required personal protective equipment (PPE). This poses significant safety risks, including the potential for falls and injuries. It is imperative that all workers adhere to safety protocols and wear appropriate PPE, such as harnesses and helmets, when working at elevated locations to ensure their safety and comply with safety regulations.</p>

<p>NO FAILURE WAS OBSERVED HERE</p> <p>The issue requires ongoing monitoring and will remain a focus for the consultant during the next visits.</p>
<p>4. Dust Issue</p> <p>Dust mitigation measures should be implemented along the RoW of the road.</p>

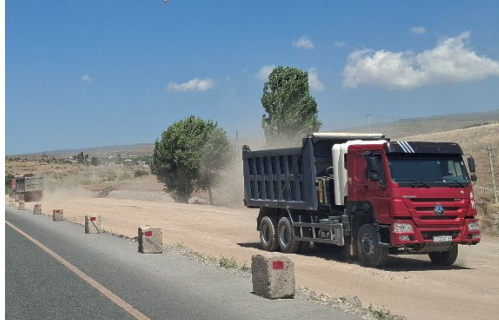
<p>During the monitoring visit on June 27, no watering activities were observed, despite the dry weather and the evident need for watering along the construction site.</p> <p>The issue requires ongoing monitoring and will remain a focus for the consultant during the next visits.</p>

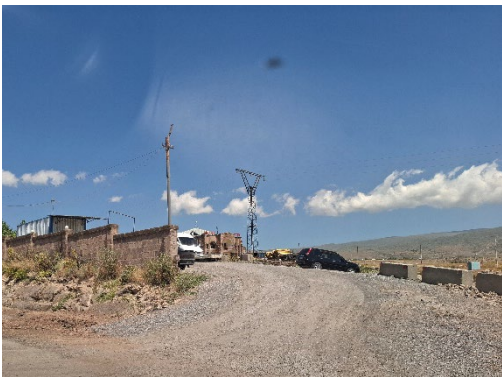
TASK 2		
Issue/Observation	Photos	UPDATE as of 27.06.25
<p>5. Main road exits</p> <p>Exits to the main road are not filled with crushed stone.</p> <p>Exits to the main road must be filled with crushed stone to reduce pollution of the main road.</p>

<p>NO FAILURE WAS OBSERVED HERE</p> <p>The issue requires ongoing monitoring and will remain a focus for the consultant during the next visits.</p>
<p>6. Cover for Trucks:</p> <p>Trucks should be provided with cover.</p>

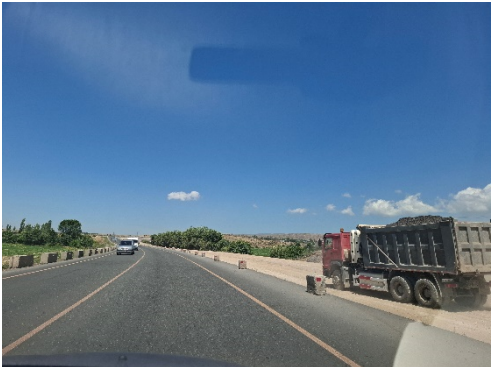
<p>STATUS: PENDING</p> <p>The issue requires ongoing monitoring and will remain a focus for the consultant during the next visits.</p>

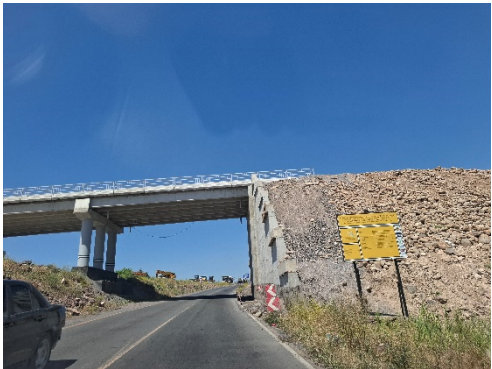
TASK 2		
Issue/Observation	Photos	UPDATE as of 27.06.25
<p>7. Information Boards Project Information boards are missing.</p>

<p>NO FAILURE WAS OBSERVED HERE</p> <p>Project Information boards were installed.</p>
<p>8. First Aid Kit: Properly stocked First Aid Kit must be provided.</p> <p>An expired medication was found in the first aid kit.</p>

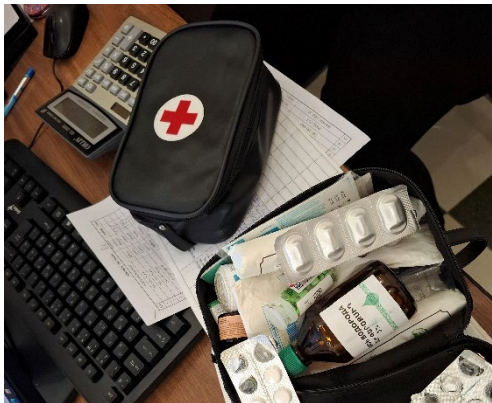
<p>STATUS: RESOLVED</p> <p>The issue requires ongoing monitoring and will remain a focus for the consultant during the next visits.</p>
