# Initial Environmental Examination

Project Number: 49244-002  
June 2026  
Document Status: Final

## Armenia: Armenia-Georgia Border Regional Road (M6 Vanadzor-Bagratashen) Improvement Project

### M6 Road Improvement

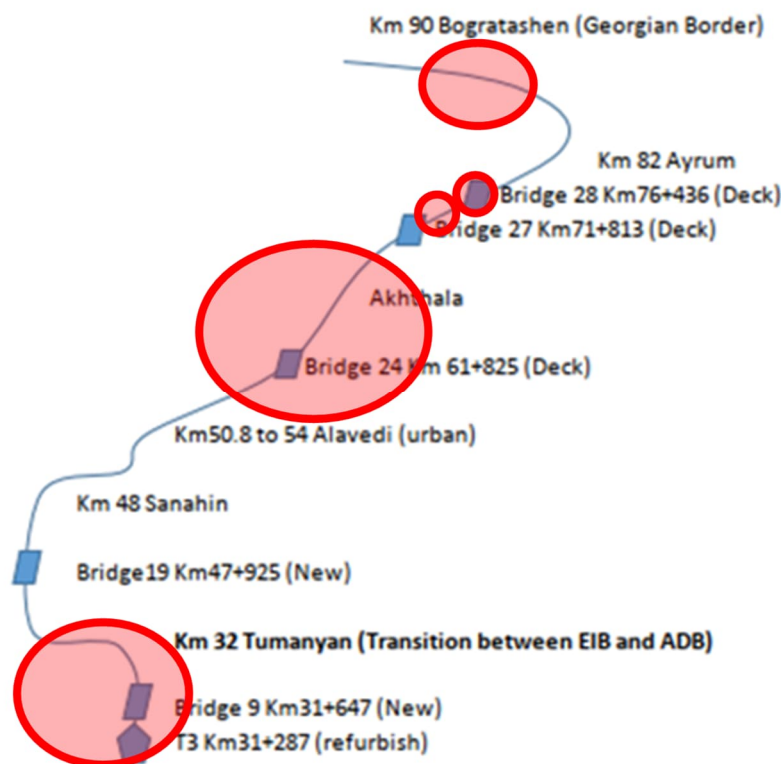
Figure 3: Alignment overview with areas of significant damage marked

65. In particular, the newly rehabilitated M6 road was seriously damaged in 30 sections with a total length of about 7 km, with the three general sections being: km 31+675 – km 39+350 (around Tumanyan); km 55+950 – km 67+620 (north of Alaverdi towards Akhtala); km 84+570 – km 85+200 (north of Ayrum towards the border with Georgia). Further significant damage was recorded between km 71 and km 72 (Shnogh) as well as at km 76+300 (Artchis).

66. A map showing the main areas of damage is shown below followed by pictures of the damage and a quantified summary of damages in the 30 sections.

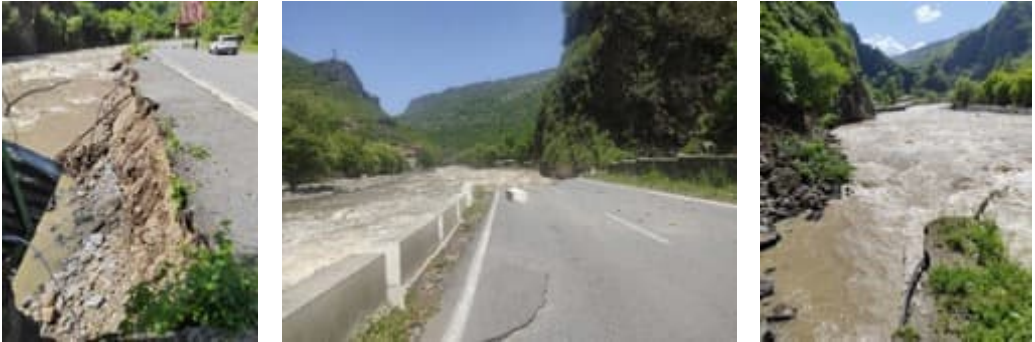
NO.	LOCATION, KM POSITION	DAMAGED ROAD ELEMENT	QUANTITY M	PHOTOS BEFORE TEMPORARY REHABILITATION
1	31+675-32+765	R/c culvert d=1m	16.25

Retaining wall	285	
		Embankment	380	
		Shoulder	660	
		Paved shoulder	23	
		Sidewalk	7	
		Pavement	325	
		Concrete parapet	255	
2	33+030	Retaining wall	36

*Table 4: Summary table of damages caused by the 2024 flood and photographic examples*

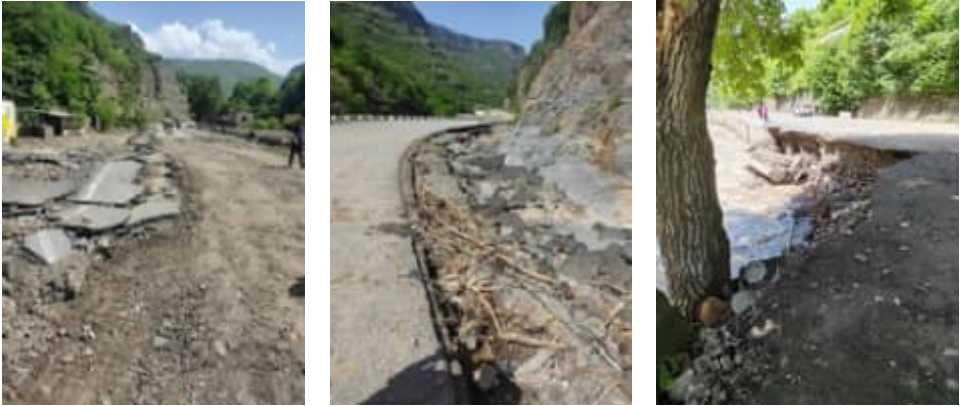
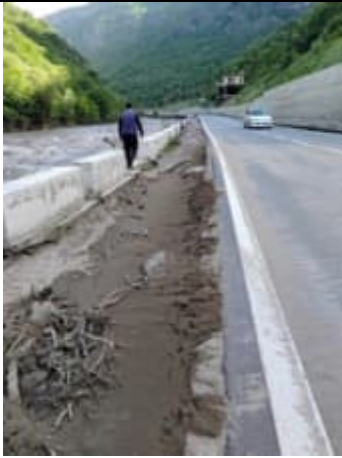
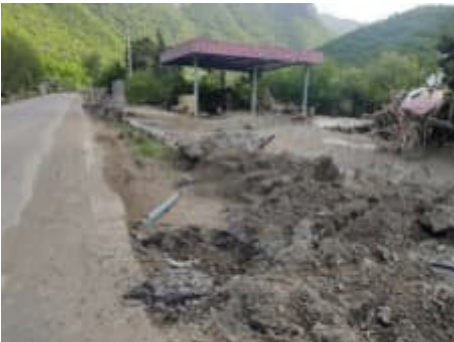
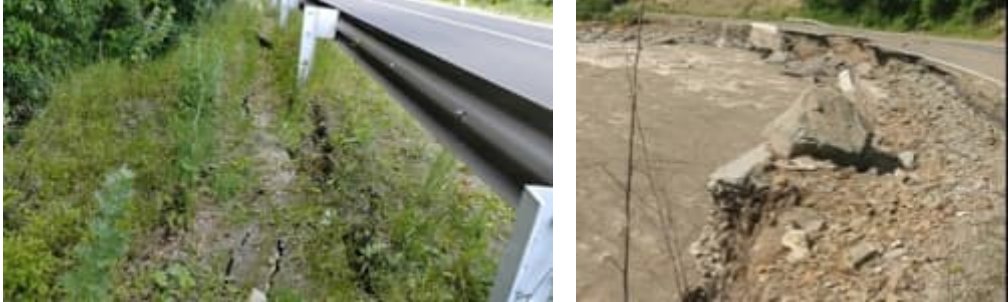
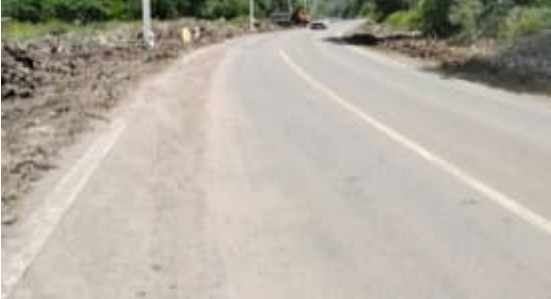
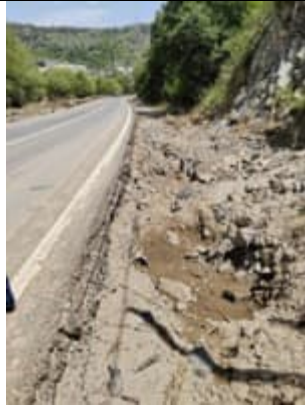
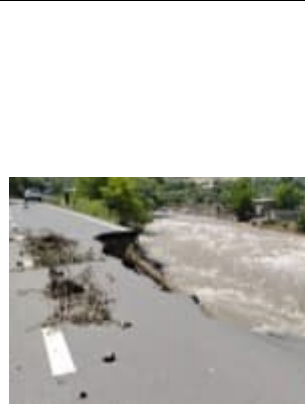
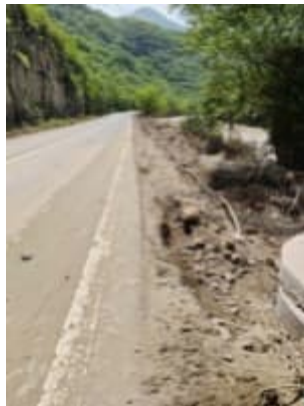
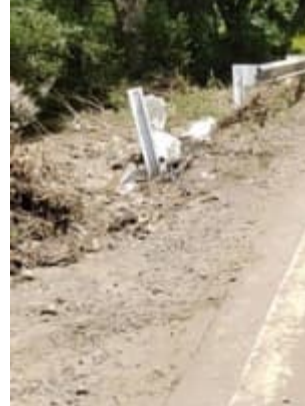
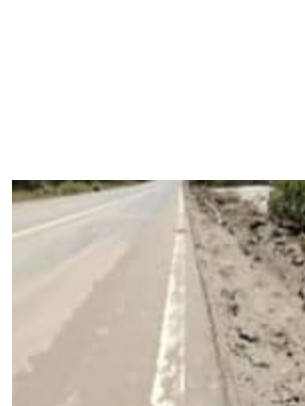
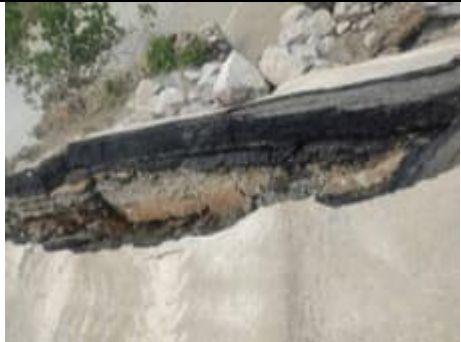
Paved shoulder	18	
		Sidewalk	18	
		Concrete parapet	13	
3	33+165-33+860	Retaining wall	230

6	35+250- 35+760	Retaining wall	160	   
		Shoulder	320	
		Embankment	160	
		Gabions	340	
		Pavement	160	
		Concrete parapet	160	
7	37+100- 37+150	Embankment	50	   
		Shoulder	50	
		Guardrails	25	
8	37+510 - 37+800	Embankment	40	   
		Retaining wall	40	
		Shoulder	500	
		Pavement	60	
		Concrete parapet	110	
9	38+400 - 38+450	Embankment	20	 
		Shoulder	20	
		Concrete parapet	10

10	39+100-39+350	Shoulder	250

Concrete parapet	10	
11	55+950-56+270	Shoulder	640

Guardrails	20	
		Flumes	110	
12	56+450-56+540	Retaining wall	90	
		Embankment	80	
		Shoulder	90	
		Concrete parapet	10	
13	56+900-57+050	Embankment	150	
		Gabions	150	
14	57+230-58+340	Retaining wall	560	
		Embankment	420	
		Shoulder	580	
		Pavement	130	
		Concrete parapet	130	
		Guardrails	16	
		Flumes	160

15	58+990-59+070	Retaining wall	80	 
		Embankment	80	
		Shoulder	80	
		Pavement	30	
		Concrete parapet	80	
16	60+560-60+640	Retaining wall	7	 
Embankment	80			
Shoulder	50			
Concrete parapet	7			
17		Embankment	30

18	63+305-63+330	Embankment	25

19	63+450-63+610	Retaining wall	100	
		Embankment	160	
		Shoulder	160	
		Pavement	30	
		Concrete parapet	100	
		Guardrails	9	
20	66+650-66+965	Shoulder	315

21	67+050-67+300	Embankment	250	
		Shoulder	250	
		Pavement	15	
		Guardrails	200

22	67+360-67+620	Flumes	250

Embankment	50	
		Shoulder	520	
23	71+090	Embankment	30

24	71+250-71+400	Embankment	150	
		Shoulder	150	
		Guardrails	66	
		Flumes	100	
25	76+300-76+370	Retaining wall	70

Embankment	70	
		Shoulder	70	
		Pavement	70	
		Concrete parapet	70

26	84+570-84+640	Concrete parapet	18	 
27	84+880	Retaining wall	4	
		Embankment	25	
		Shoulder	30	
		Concrete parapet	4	
28	85+050	Retaining wall	15	
		Concrete parapet	15	
29	85+540-85+620	Shoulder	80	
30	85+670-86+200	Shoulder	1060

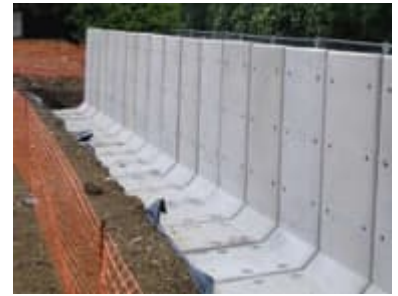
The flood-protection concept utilizes L-shaped pre-cast concrete (PCC) retaining wall elements, each with a height of 1,5 m, a base width of 1,5 m, and a unit length of 3,0 m. These modules are deployed along road sections that are regularly exposed to flooding and are intended to protect the road structure from excessive hydraulic forces. Importantly, the system is not designed to keep the road surface dry; rather, it provides structural protection while allowing controlled inundation.

The L-shaped geometry offers high stability, with mass and leverage that effectively resist sliding and overturning under design-level hydraulic loads. The retaining wall does not interfere with the river's natural flood retention volume: water is able to pass behind the wall through integrated drainage openings (DN 250, spaced at 3.0 m), and additional flow can spill over the wall crest when water levels exceed the element height. This ensures that the retention volume of the river remains intact and that downstream water levels are not artificially increased.

Allowing water to pass behind and over the retaining wall creates a still-water zone on the road, which acts as a secondary retention area while remaining hydraulically connected to the river. This still-water volume significantly reduces shear stress and flow velocity along the road embankment during flood events. By lowering the hydraulic loading on the road structure and associated embankments, the system effectively minimizes erosion risk, scouring, and structural damage.

The modular PCC elements enable rapid installation, reliable manufacturing quality, and straightforward replacement of individual units if required. Overall, the retaining wall system provides a robust, low-maintenance, and hydraulically compatible measure for safeguarding road infrastructure in flood-prone sections.

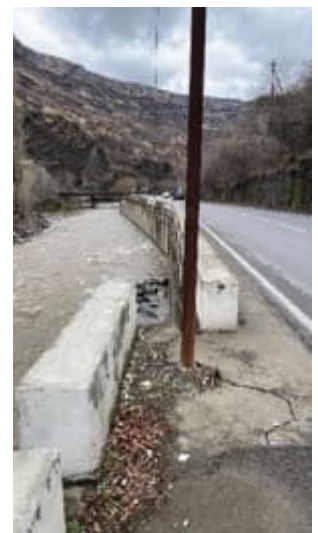
Cast-in-place cantilever retaining walls are applied in sections of the road corridor where geometric restrictions limit other protection options. These in situ poured concrete structures are adapted to the specific local conditions, ensuring that the structural configuration meets both hydraulic and geotechnical requirements.

The cantilever walls are particularly used in narrow areas of the gorge where there is no available space for riprap solutions. Their vertical alignment minimizes the required space taken from the Debed river while still providing a robust barrier capable of withstanding hydraulic forces during flood events. The foundation is constructed beneath the riverbed, offering enhanced stability against scour and dynamic hydraulic pressures. To further safeguard the structure, the foot of the wall is protected with a layer of riprap, reducing local erosion and ensuring long-term performance.

As with the pre-cast concrete retaining walls, the cantilever wall system is not intended to keep the road dry; rather, it provides structural protection while allowing water to inundate the road in a controlled manner. This approach enables the creation of a still-water zone on the road surface, which helps

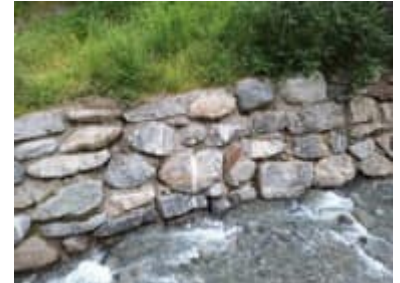
The Riprap was selected as a nature-based solution for bank protection. The large-stone riprap consists of carefully chosen rocks, typically weighing between 1.000 and 3.000 kg. The stones are placed in such a way that each rock interlocks on all four sides. This interlocking arrangement provides strong resistance to water-induced shear forces as well as impact forces from rocks, trees, and transported sediments. The riprap foundation includes a foot stone weighing between 3.000 and 6.000 kg, which must be set 1.6 m below the riverbed.

This approach represents a flexible protection measure that can accommodate local changes and can show early signs of damage without sudden or complete failure. The riprap walls are planned with slopes ranging from 1:1,2 (vertical : horizontal) to 3:1. Riprap with a 1:1,2 slope will be constructed dry (without concrete filling) for riprap heights below 8,5 m (vertical). The backfilling behind the riprap will be executed using gravel with a grain size of 16/32. For higher riprap structures a C20/25 filling for the lower 3 rock rows and the foot stone is necessary to resist the seismic loads. Steeper slopes, however, concrete filling becomes necessary throughout the whole height of the riprap.

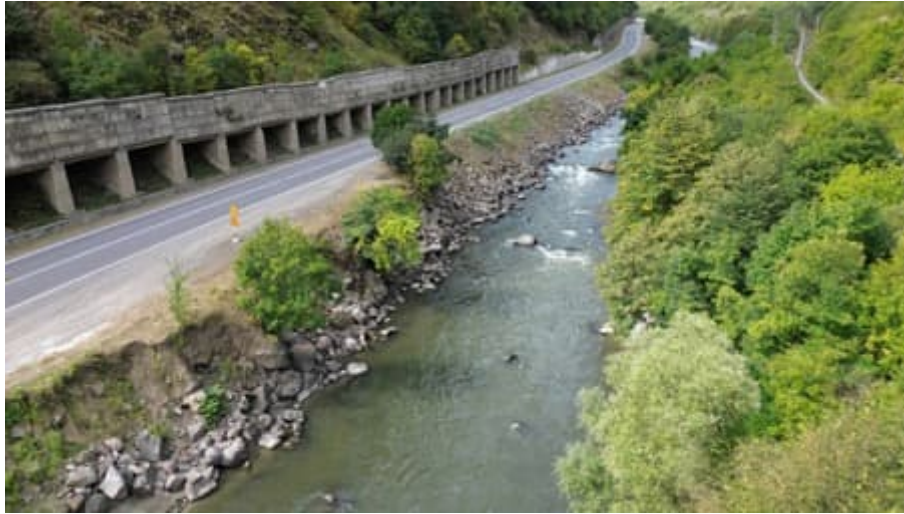
Figure 5: Drone photo of the river and road section with the buttress wall

1. Remove rubble and loose stones behind the wall
2. Excavation and securing the excavation pit
3. Drill and glue fixing brackets into the stones (4 per stone block)
4. Produce floor slabs
5. Concrete walls in sections:  $H_{max} \leq \text{stone height or } \leq 1.00\text{m}$
6. Backfill with suitable material
7. Install rockfall protection netting according to the drawings

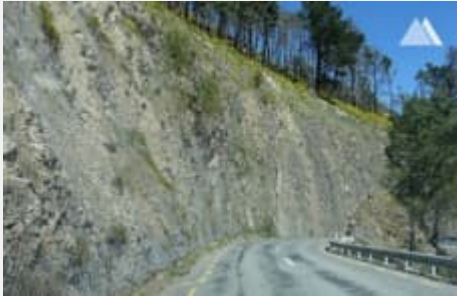
NO.	SOLUTION	REGIME DESCRIPTION	PHOTOGRAPHIC EXAMPLE
	1d: Ditch with concrete barrier and fence	<p>pose a risk of the blocks bouncing over the barrier.</p> <p>A ditch for the purposes of drainage and providing an additional barrier to falling rocks is included in all design options.</p>	
2	Conformal netting on rock face	<p>Conformal rock netting involves fastening the woven steel net over the rock face by means of rock bolts, spike plates, and border ropes, such that it follows the contours of the face and holds tightly against it. The purpose of this is to prevent unstable blocks from detaching from the rock face, or if they do detach, hold them firmly against the rock face.</p> <p>This not only prevents falling rocks, but also stabilises the face as a whole, thanks to the dense bolting grid.</p> <p>Installing conformal nets requires specialist workers and equipment to drill the bolt pattern and place the netting. For this reason, the height of netting was limited to 12 m, as this is the height generally reachable by self-loading cranes on commonly used trucks. In cases where cliffs were higher than this, rockfall protection fences or other solutions were used in combination with conformal netting.</p>

<p>[Source: Geobrugg]</p>

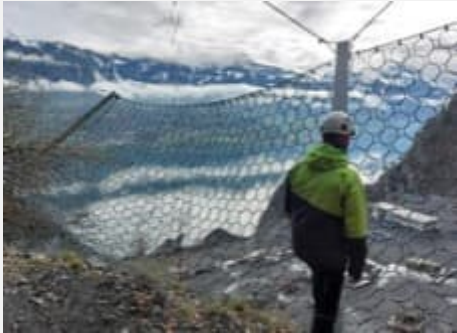
4	Rockfall protection fences	<p>Rockfall protection barriers are a common method of protecting against high-energy rockfall. They are composed of high-strength fencing held up by posts (often hinged at the base), anchored into the slope, and braced with similarly anchored steel cables. Such systems are used globally and offered by a variety of manufacturers. They are generally rated by the maximum kinetic energy they can safely absorb, with ranges from hundreds of kJ to 8000kJ currently on the market.</p> <p>Rockfall protection barriers were used both as standalone protection measures and in concert with conformal netting to provide comprehensive protection at cliffs too tall to be netted fully.</p> <p>For simplicity of design, logistical convenience, and ample safety margin, barriers rated to 2000kJ were specified for all localities in the Project area.</p>

<p>[Source: Consultant]</p>

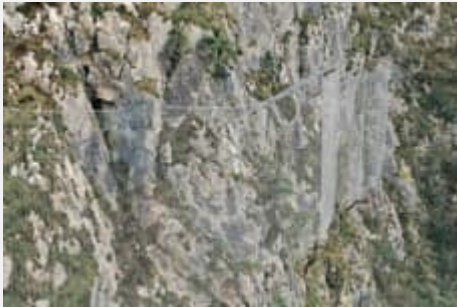
6	Hybrid rockfall barrier	<p>Hybrid rockfall barriers, also known as attenuators, are an innovative solution to rockfall protection that can, in appropriate settings, offer energy absorption comparable to many rockfall protection barriers while requiring significantly less maintenance.</p> <p>They are composed of a high-strength steel net suspended on posts (hinged at the base) on the hillward side and allowed to hang freely or rest</p>

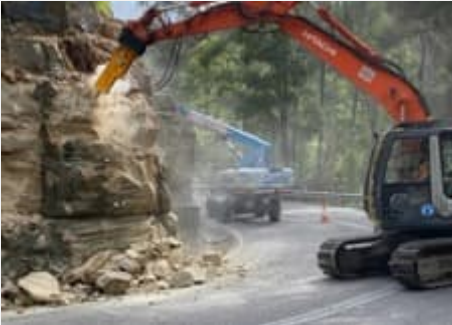
NO.	SOLUTION	REGIME DESCRIPTION	PHOTOGRAPHIC EXAMPLE
		on the slope on the valley side. This allows the net to swing freely under impacts, absorbing significant energy, and funnelling the incoming blocks to a collection area at the foot of the cliff, whence they can be easily removed. The ease of removing fallen blocks, combined with reduced reliance of semi-consumable steel brakes greatly reduces the maintenance effort required for this type of system. It should be noted, however, that it can only be used in locations where sufficient space is available for constructing a safe collection area.	[Source: Geobruigg]
7	Wholesale removal of free-standing, hazardous rocks	<p>In most cases, managing rockfall hazard by simply removing rock outcrops is impractical or outright impossible due to the topography around the outcrops or the scale of the excavation that would be necessary.</p> <p>Despite this, in specific cases, hazards originate from localised, free-standing rocks, whose removal poses a realistic and permanent solution to the rockfall or slope stability issues at the locality. This option is therefore maintained and currently applied at one locality.</p> <p>This is a non-trivial excavation involving potentially unstable rock masses that requires specialist planning the use of appropriate methods, including mechanical breaking or blasting, which should be planned by a specialist site engineer.</p>

<p>[Source: <a href="https://www.shotcreteconcrete.com/">https://www.shotcreteconcrete.com/</a>]</p>

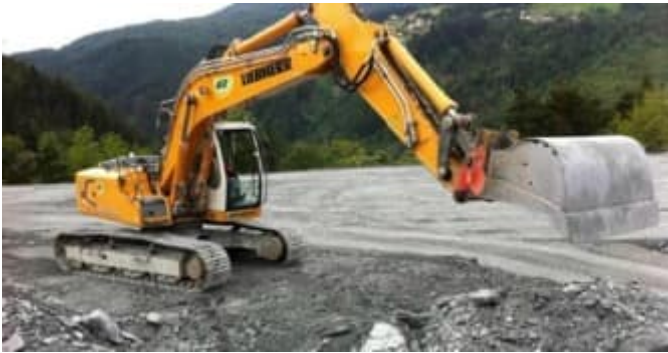
Figure 6: Excavator with attached slope-work bucket in operation

If possible, excavated topsoil material from the site should be immediately used to cover newly completed areas and seeded to limit erosion. Temporary spoil deposits shall have maximum dimensions of 2x base width to 1x the height dimensions. This height to base width ratio must not be exceeded unless specific temporary work calculations have been produced by a competent engineer and are available on site for inspection. The stability of spoil piles will remain the responsibility of the contractor. The contractor must ensure the foundation of the spoil pile/ excavated material is adequate to prevent collapse movement and/ or secondary effects on adjacent structures, systems, and components. Topsoil heaps shall be assessed, designed and maintained by the contractor to assure stability and preclude soil slip or movement. The base to height ratio shall not exceed 2:1 (as noted above).

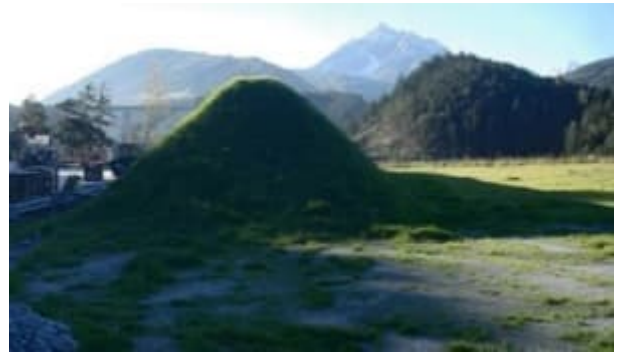
Figure 7: Example of a topsoil heap

Spoil heaps/ storage areas which will be required for more than 6 weeks shall be prepared with a trough-shaped surface to allow managed drainage, surface run off water will be managed and collected and not allowed to contaminate adjacent facilities such as rivers, water courses or land. Furthermore, the topsoil heaps shall be sowed with seeds and planting typical to the region to prevent erosion. The heaps are to be mown at least twice a year.

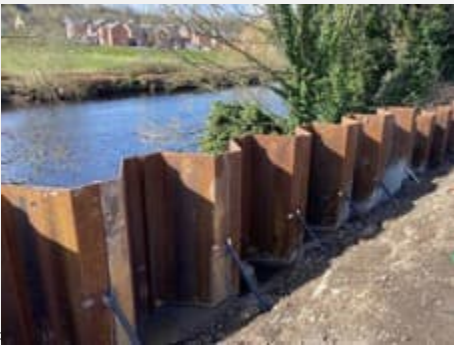
<b>OPTION</b>

<p>#</p> <p>[Source: <a href="https://www.sheetpilinguk.com/sheet-pile-river-wall-secures-mirfield-supermarket/">https://www.sheetpilinguk.com/sheet-pile-river-wall-secures-mirfield-supermarket/</a>]</p>
<b>UTILISATION</b>	<p>This detail is used in river and road construction although it is normally employed where there is a significant business and engineering justification.</p> <p>Homogeneous soft or loose ground conditions (e.g., soft clay or sandy gravel) are required for driving of sheet piles.</p> <p>This system is recommended for walls between 6-8 m if a head restraint is employed.</p>
<b>METHOD</b>	<p>Sheet piling works have significant establishment requirements and generally require a large plant in the form of a piling rig and crane in attendance together with a large 360° excavator as well as a significant laydown area. Clearly the laydown area in the case of the M6 could be positioned either along the road forward or behind the piling rig or some distance away in a logistic yard. The piling rig would be positioned on the road and the piling head would be over the river edge. Piling rigs of this nature are significant in size and would partially block the M6 road traffic.</p> <p>The piling rig once established would vibrate or hammer the sheet pile to the desired depth. This activity causes significant noise and vibration during the installation. This vibration could cause secondary issues such as social disruption and potential destabilisation of existing structures and may cause rock fall issues.</p>

<b>PROS</b>	<p>The sheet pile once installed is structurally efficient and takes minimal space in the road river environment.</p> <p>The lifespan of sheet piles can in the range of 50 to 100 years based on local conditions, material quality.</p>

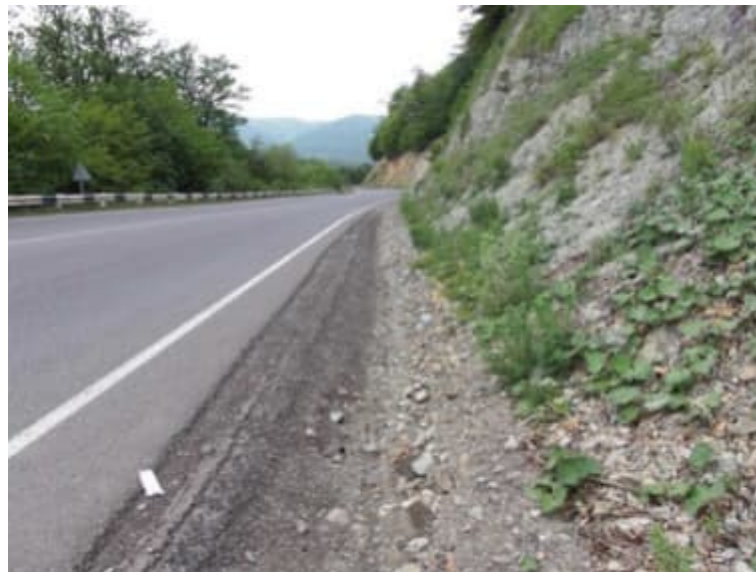
*Figure 24: Road bed of Highway M6*

#### *J4.21 – Road-bed (Figure 24).*

M6 highway has an asphalt pavement.

*J4.21 – Road-bed (Fig. 10).*  
M6 Highway has asphalt covering.

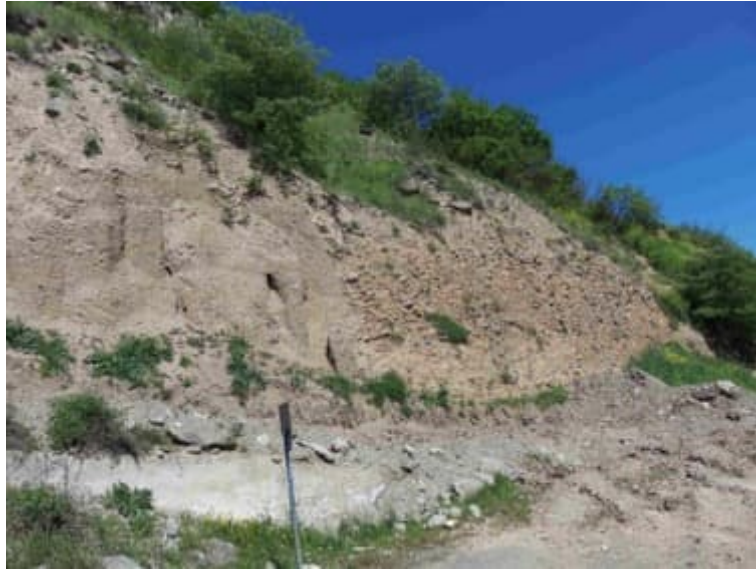
Figure 25: Road's escarp

#### *J4.23 – Mountain roads escarps (Figure 25)*

Escarps near mountain roads were built during roads building or enwidening. They can be bare or vegetated. Their height may be up to 15-20 m.

*J4.23 – Mountain roads escarps (Fig. 11)*

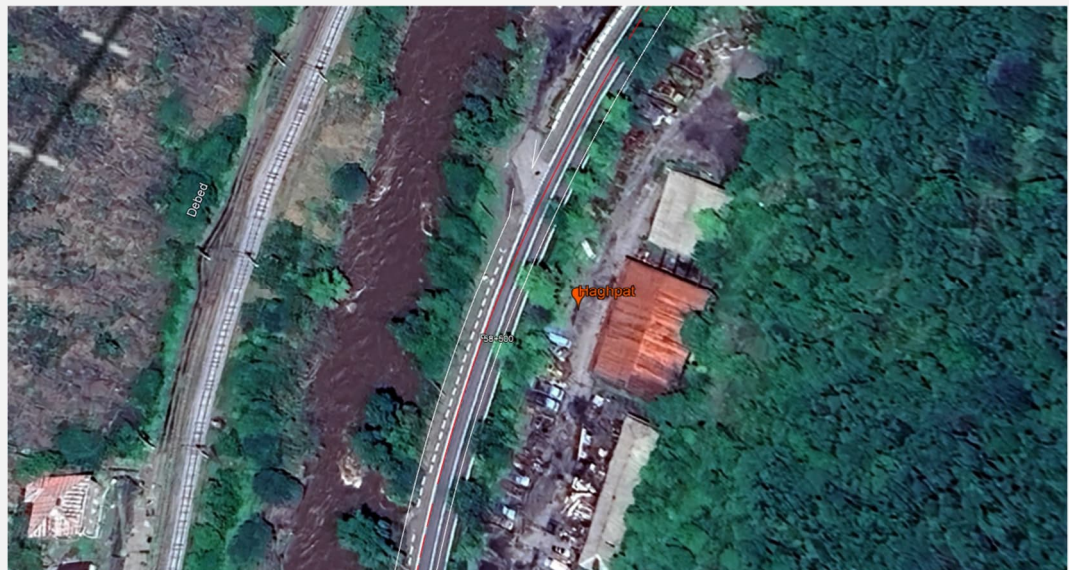
km 58+500 is north of Alaverdi in a narrow section of the Debed Gorge. The measurement point at the building is located slightly above the road.

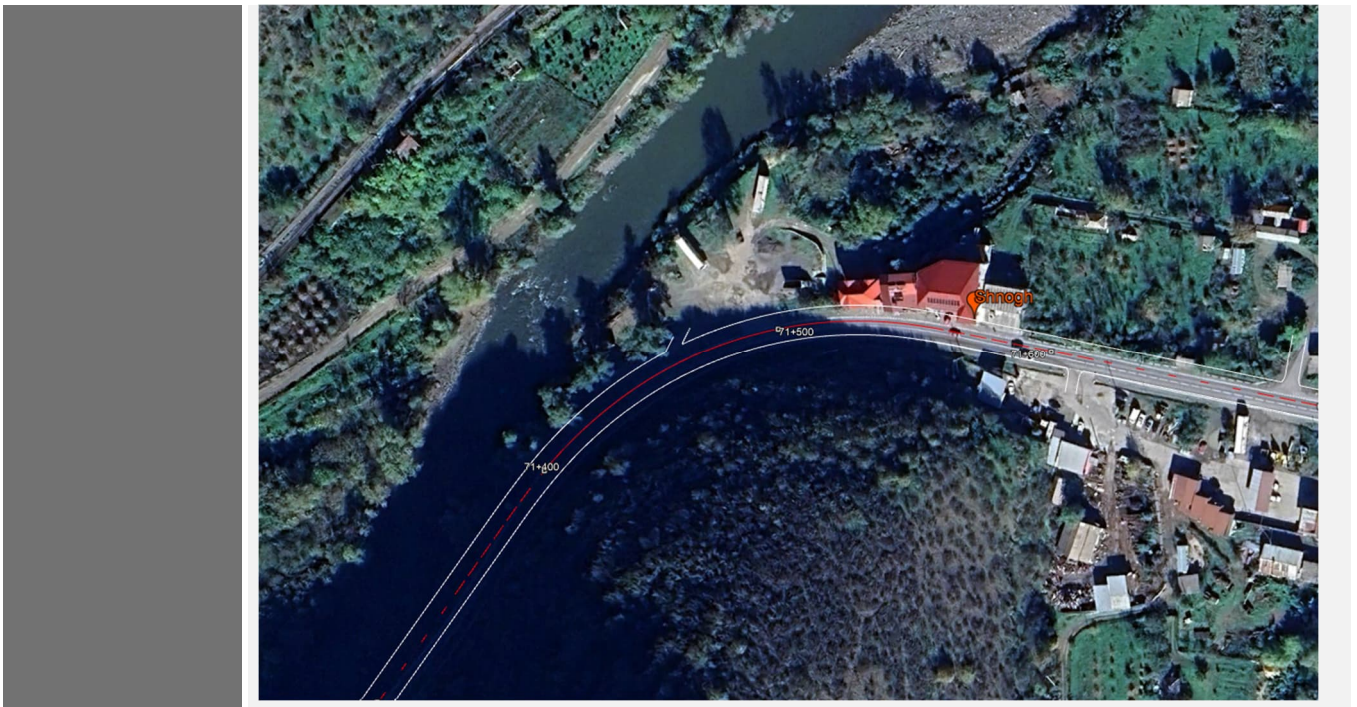
The measurement point at 71+550 is located next to the road.

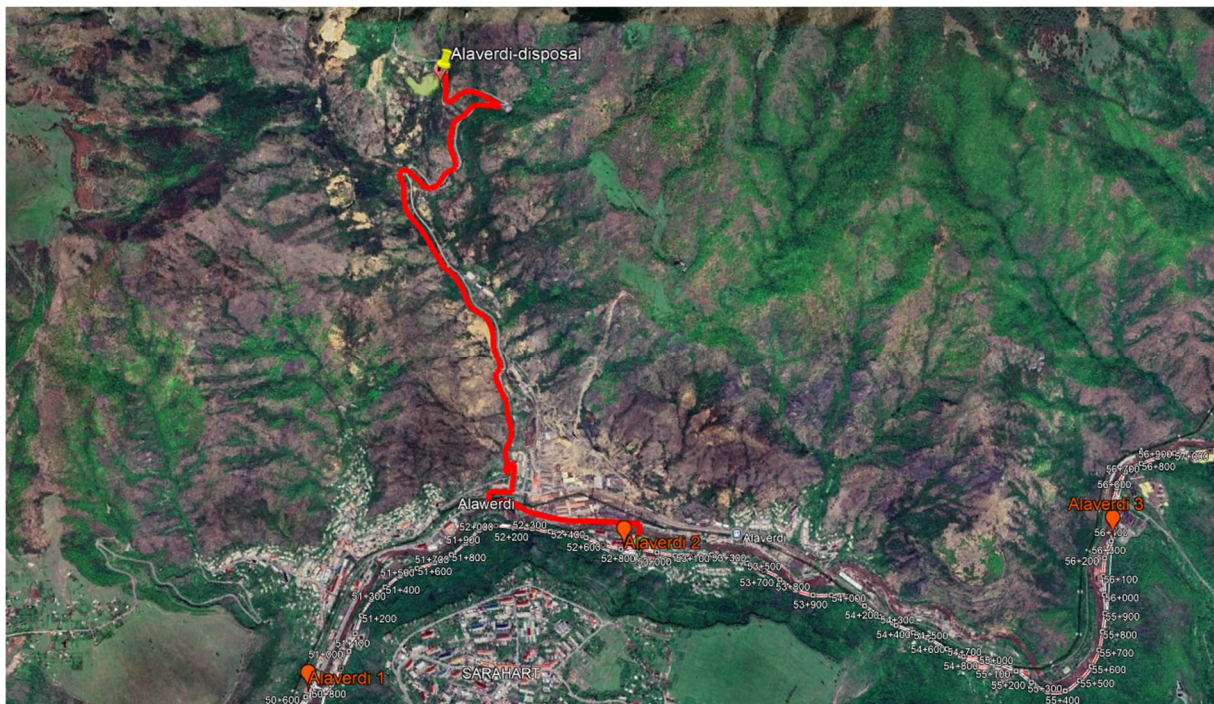
Figure 34: Location of area and transport route for waste disposal in Alaverdi area

The Alaverdi Community has offered an area for disposal of non-recyclable construction waste located in the northwest part of Koshaberd Street in Alaverdi city, approx. 4.5 km from nearest turnoff of the M6 at km 52+900. The route is identified in Figure 34 below. The area is approx. 12,000 m<sup>2</sup> and is accessible by existing, paved roads. It is used as the community disposal area. The official letter concerning this area from the Alaverdi Community is enclosed with this report in **Appendix M**.

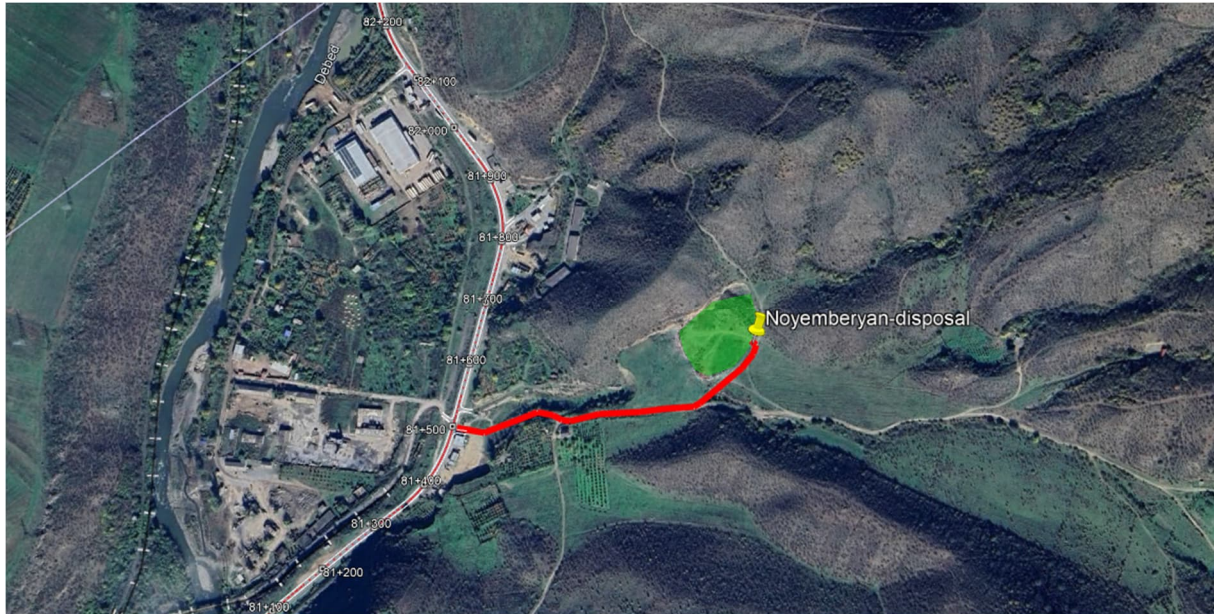
Figure 35: Location of area and transport route for waste disposal in Noyemberyan area

The Noyemberyan Community has also offered an area for disposal of non-recyclable construction waste within the administrative territory of Haghtanak Village, in the area known as “Khechi Dzor”, approx. 500 m from nearest turnoff of the M6 at km 81+500. The route is identified in Figure 34 below. The area is approx. 12,000 m<sup>2</sup> and is accessible by an existing, unpaved road. It is used as the community disposal area. The letter concerning this area from the Noyemberyan Community is enclosed with this report in **Appendix M**.

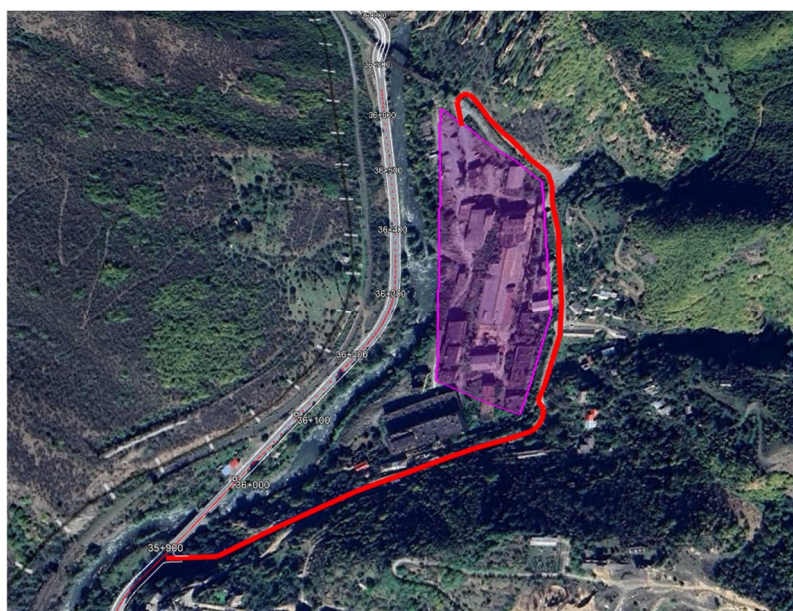
Figure 36: Previous contractor camp located at a former brick factory (access from M6 km 35+900 as marked in red)

During previous rehabilitation works for the road, contractors have situated their camps at the locations shown below, and utilised existing buildings at the locations. The previous camps are all close to the M6 at km 39+500, km 56+550, and km 81+500, and are well-situated for the works to be carried out. It is the Contractor's responsibility to make appropriate arrangements for its camps.

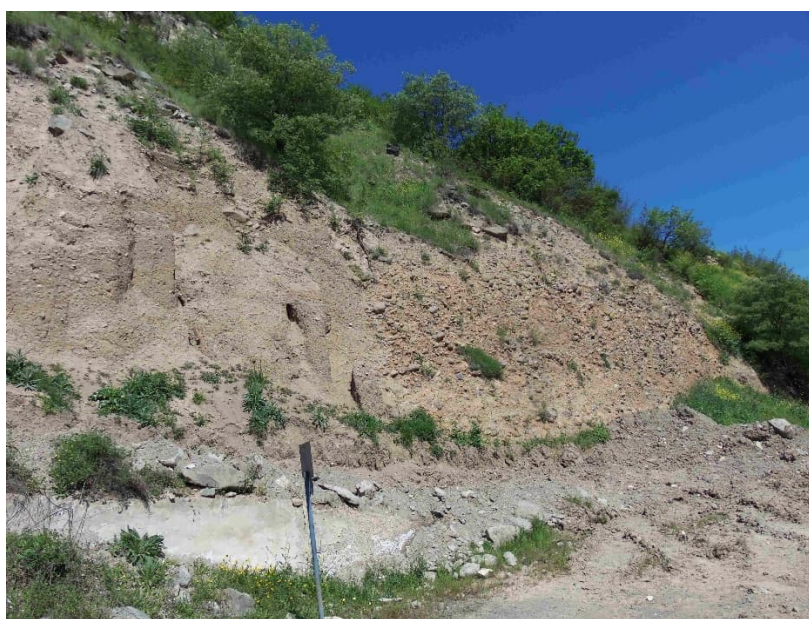
Fig. 11. Road's escarp

Escarps near mountain roads were built during roads building or enwidening. They can be bare or vegetated. Their height may be up to 15-20 m]

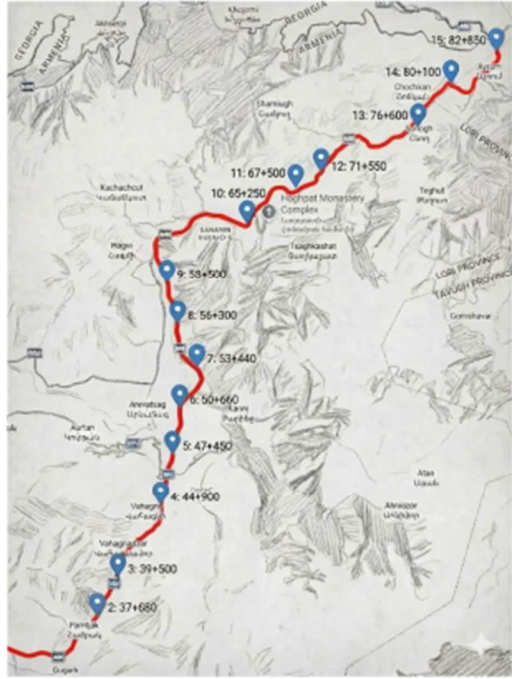
1. **Plan of the area (premises, workplace, etc.) with indication of the noise source: M6 road KM 37+860 – KM 82+900**

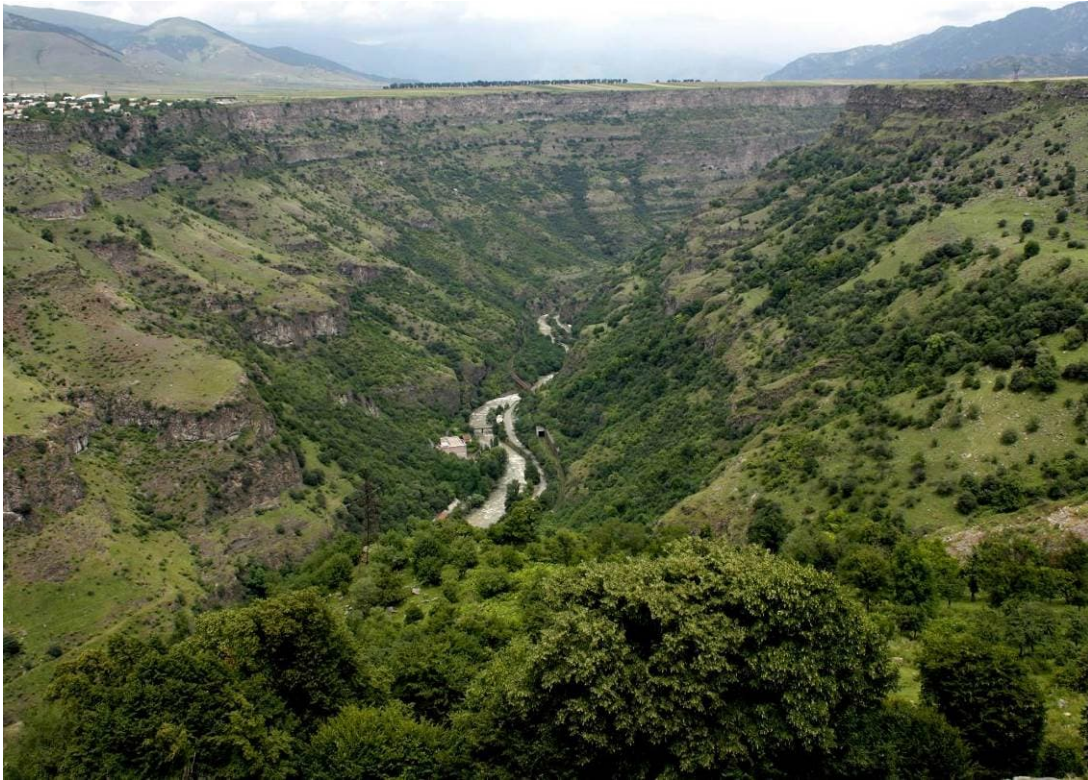
**Image 1.** The overview of the Debed River Canyon in its middle stream, near the village of Odzun (aerial image)

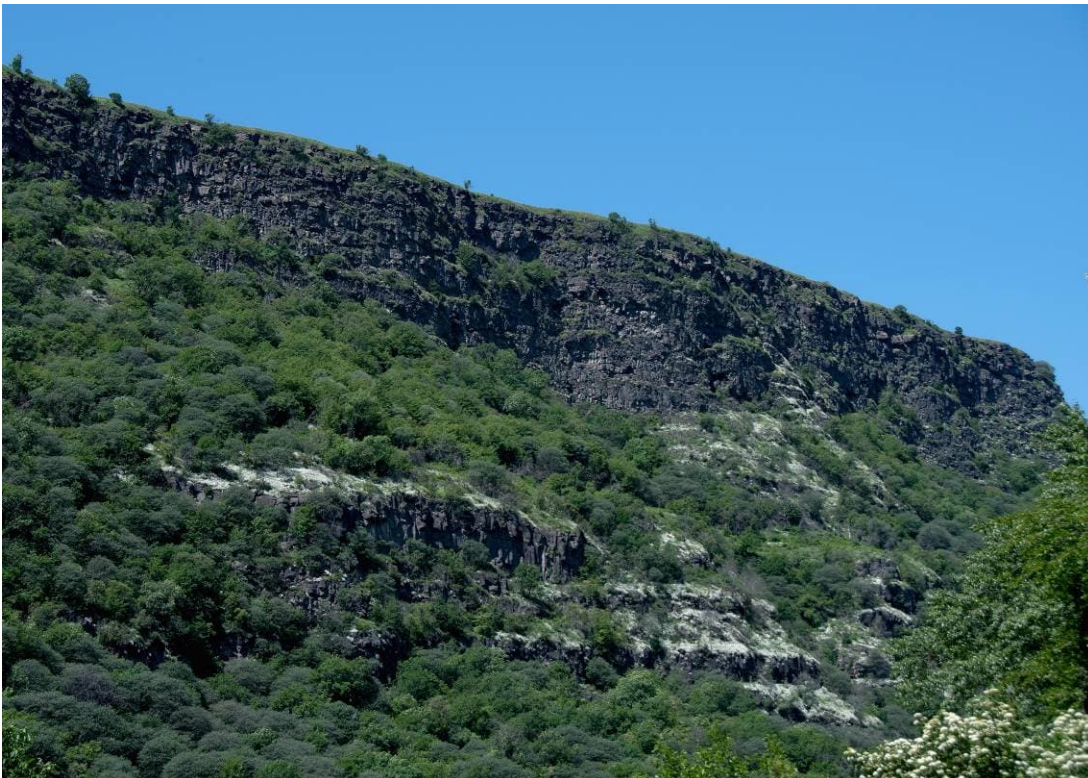
**Image 2.** The stratigraphic distribution of Lower Pleistocene basaltic lava flows shaping the Debed River Canyon

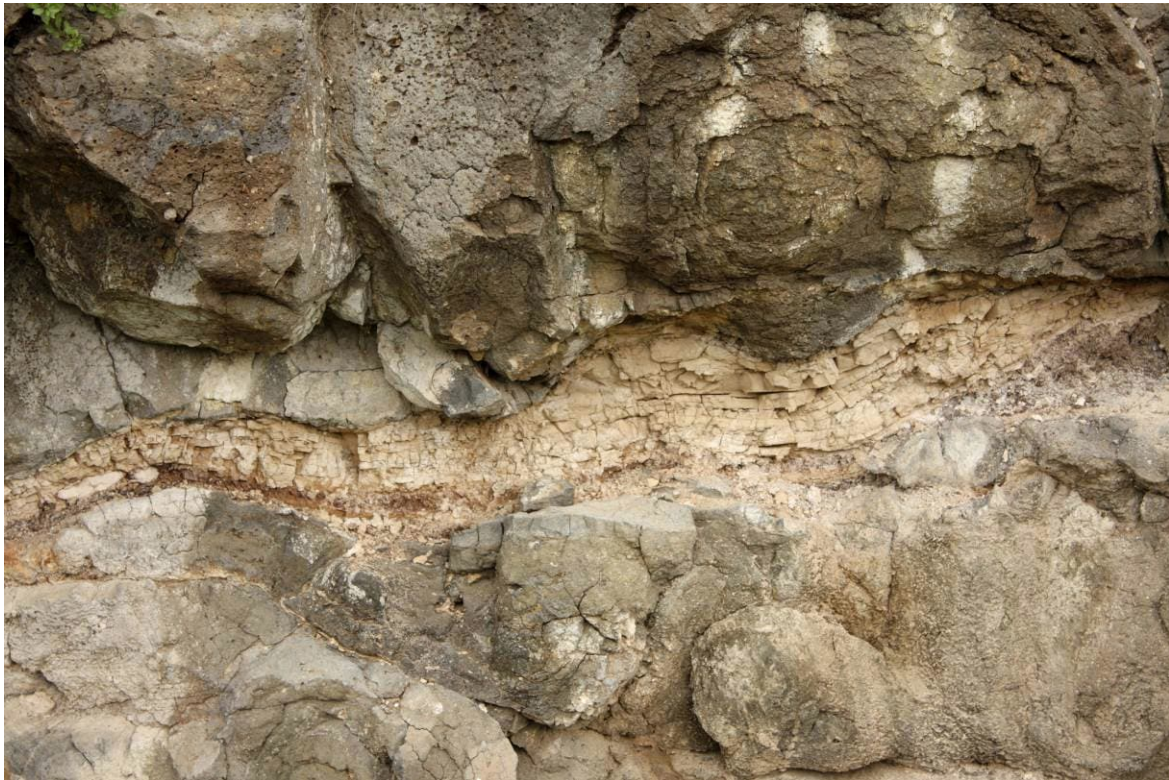
**Image 3.** Lacustral deposits lying between two basaltic flows in the Debed River Canyon

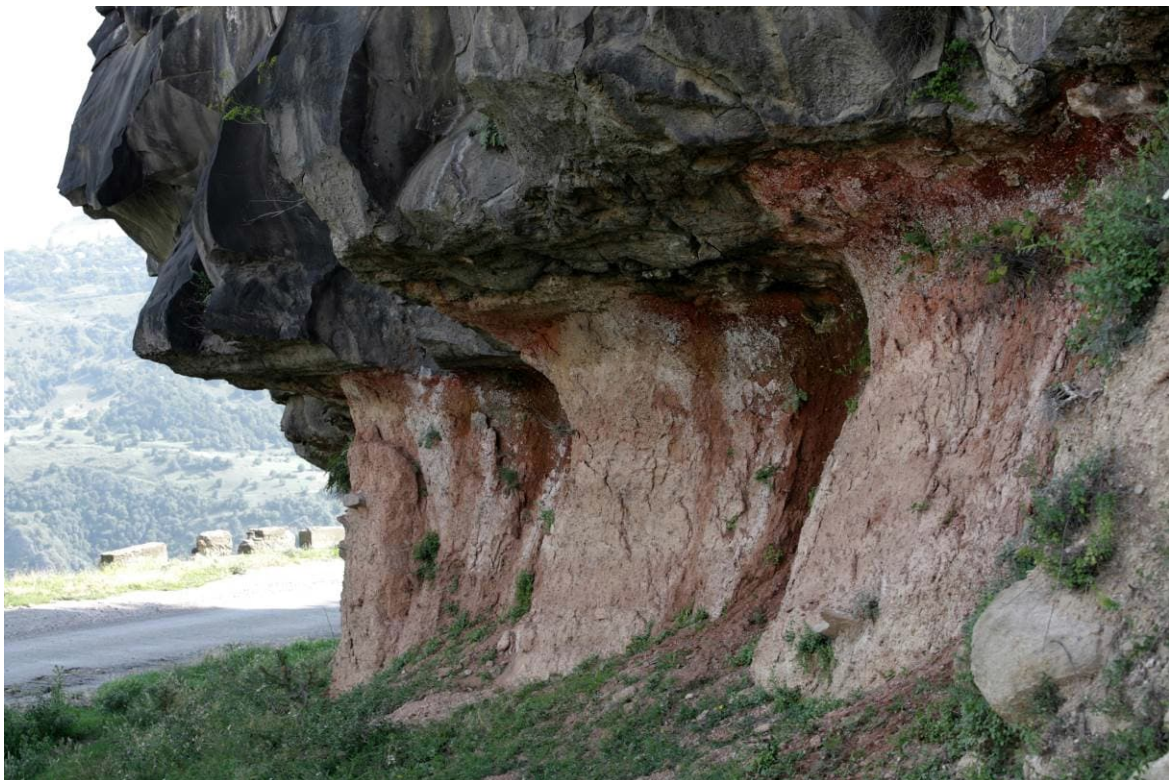
**Image 4.** Upper Pliocene deposits underlying the Lower Pleistocene basaltic flow in the Debed River Canyon

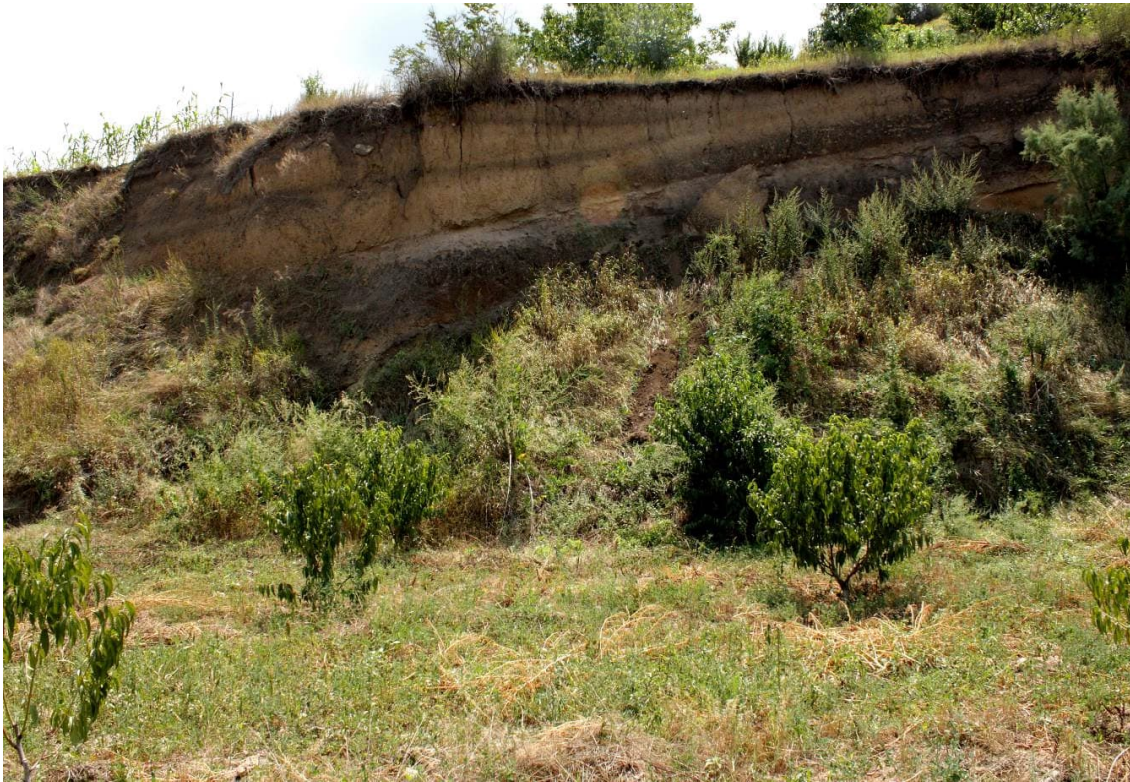
Image 5. Section of Middle-Upper Pleistocene paleosol and eolian sediments in the Debed River Canyon

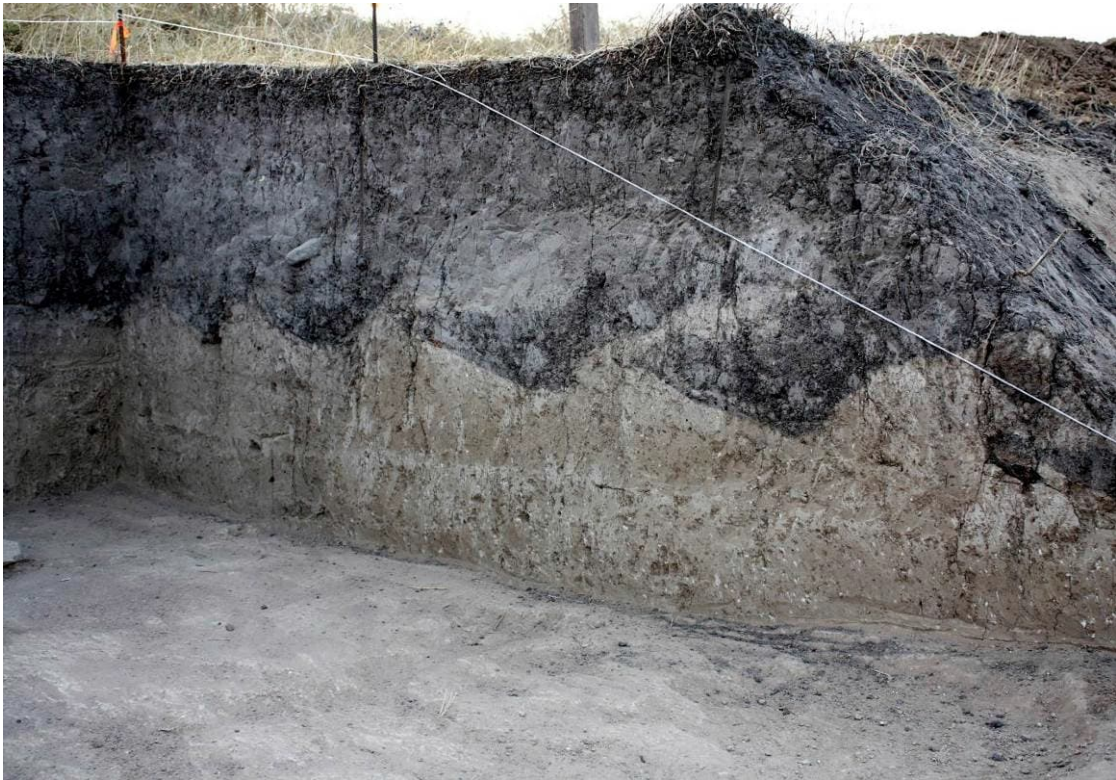
Image 6. Upper Pleistocene eolian sediments covered by black soil formations of Holocene in the Debed River Canyon

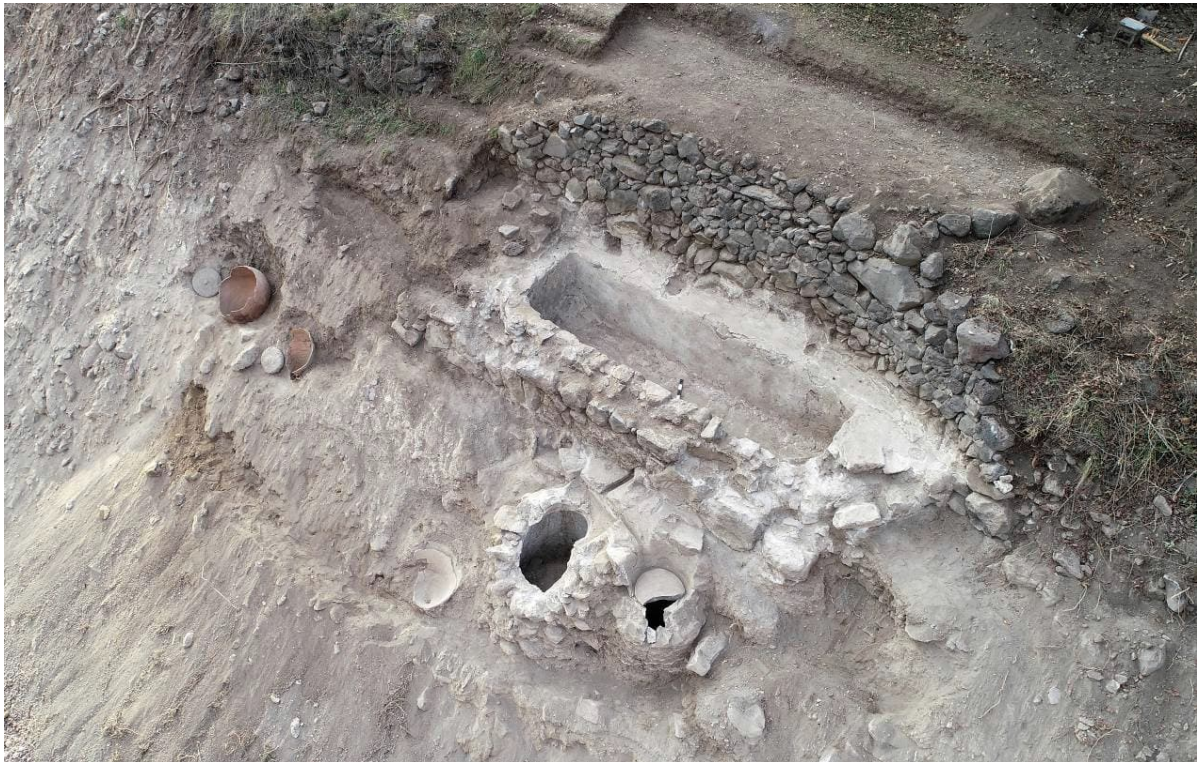
**Image 11.** The village of Kober Railroad Station. 13th-14th centuries wine production complex uncovered at the eastern ending of the "Igahat" village remains during 2018 safeguard excavations (Aerial image)

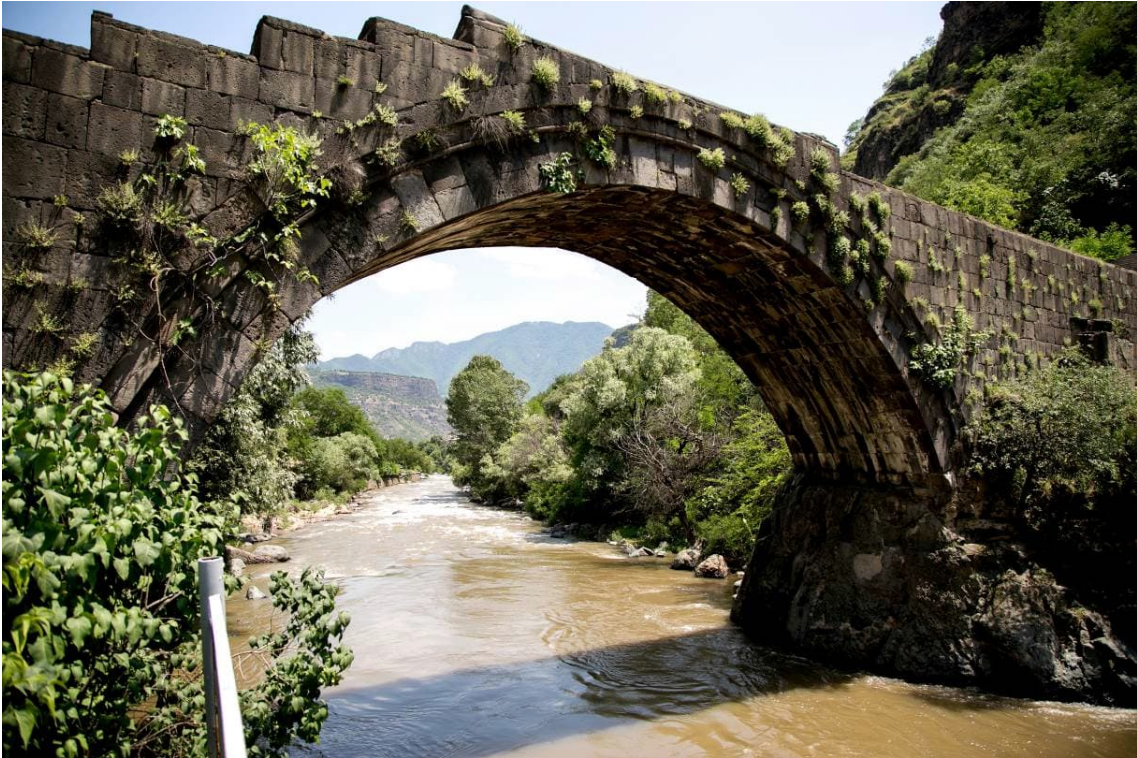
Image 19. The city of Alaverdi. 1195 Sanahin bridge built across the Debed River
