# Initial Environmental Examination

Project Number: 49244-002  
June 2026  
Document Status: Final

## Armenia: Armenia-Georgia Border Regional Road (M6 Vanadzor-Bagratashen) Improvement Project

### M6 Road Improvement

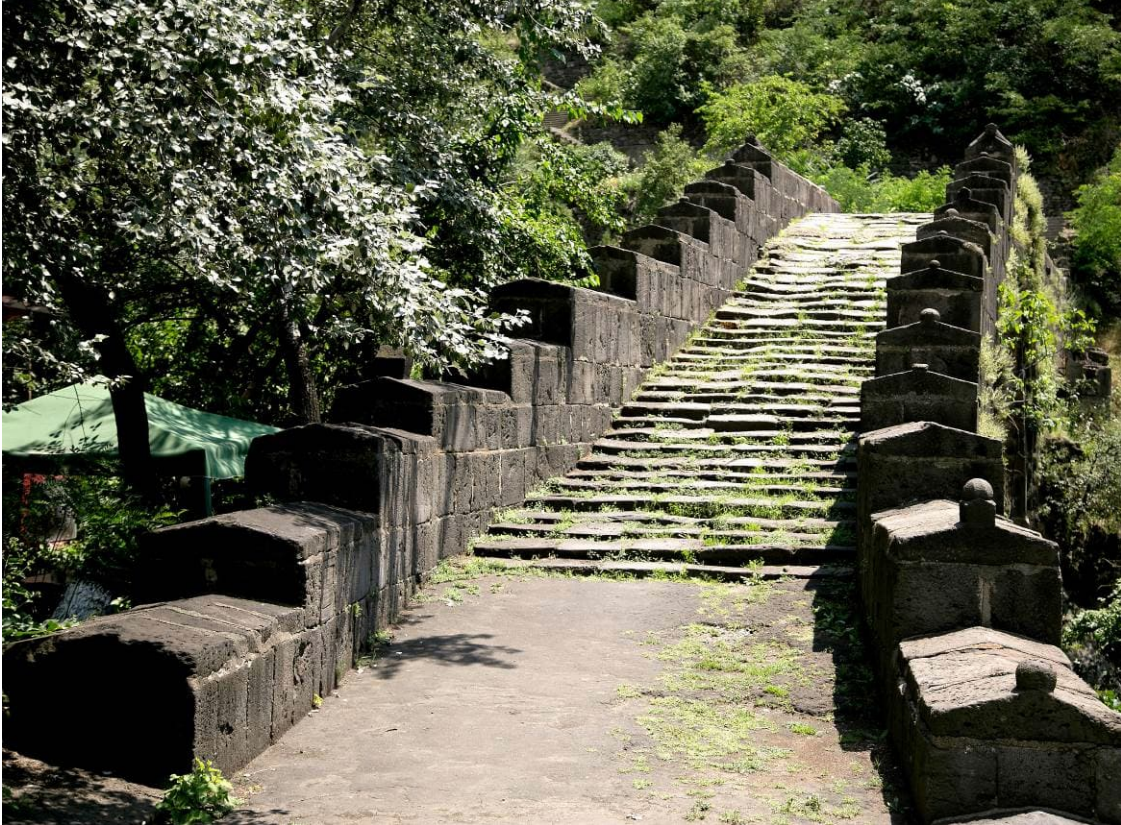
Image 20. The city of Alaverdi. 1195 Sanahin bridge built across the Debed River

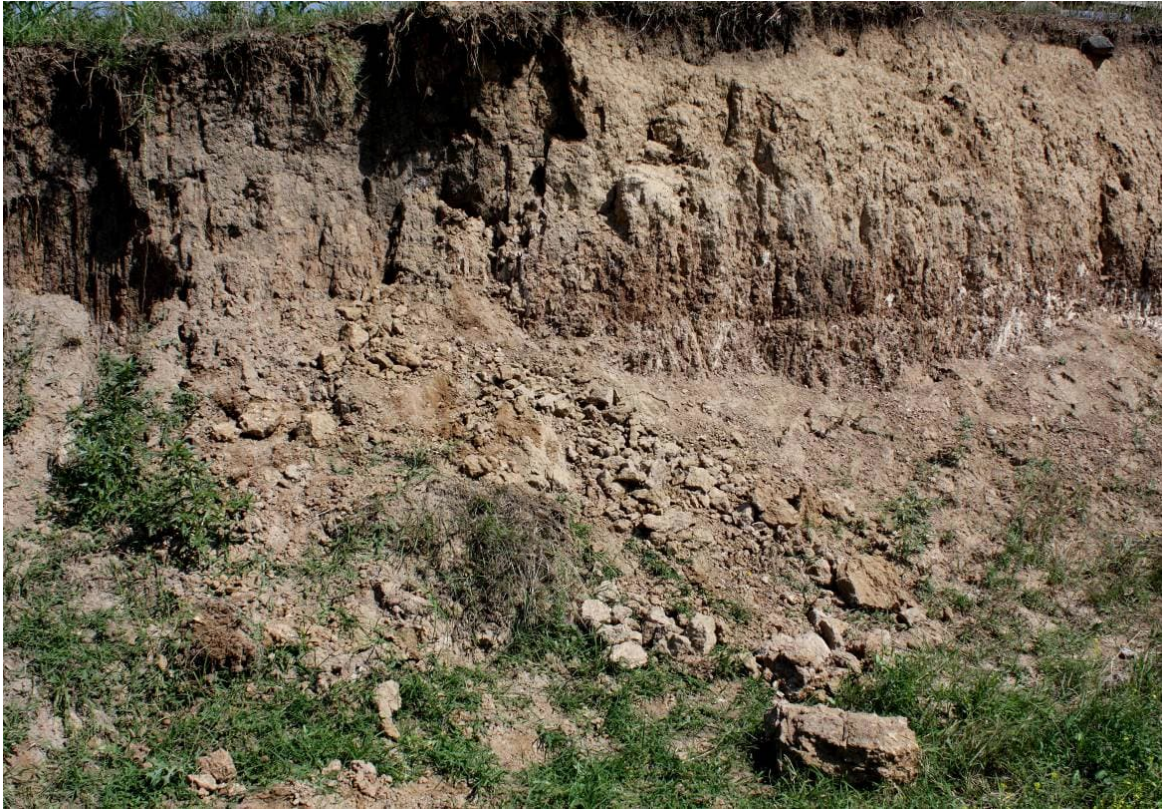
**Image 23.** The village of Bagratashen. The section of Bagratashen-3 Middle Paleolithic open-air site where the paleosol find layer is visible

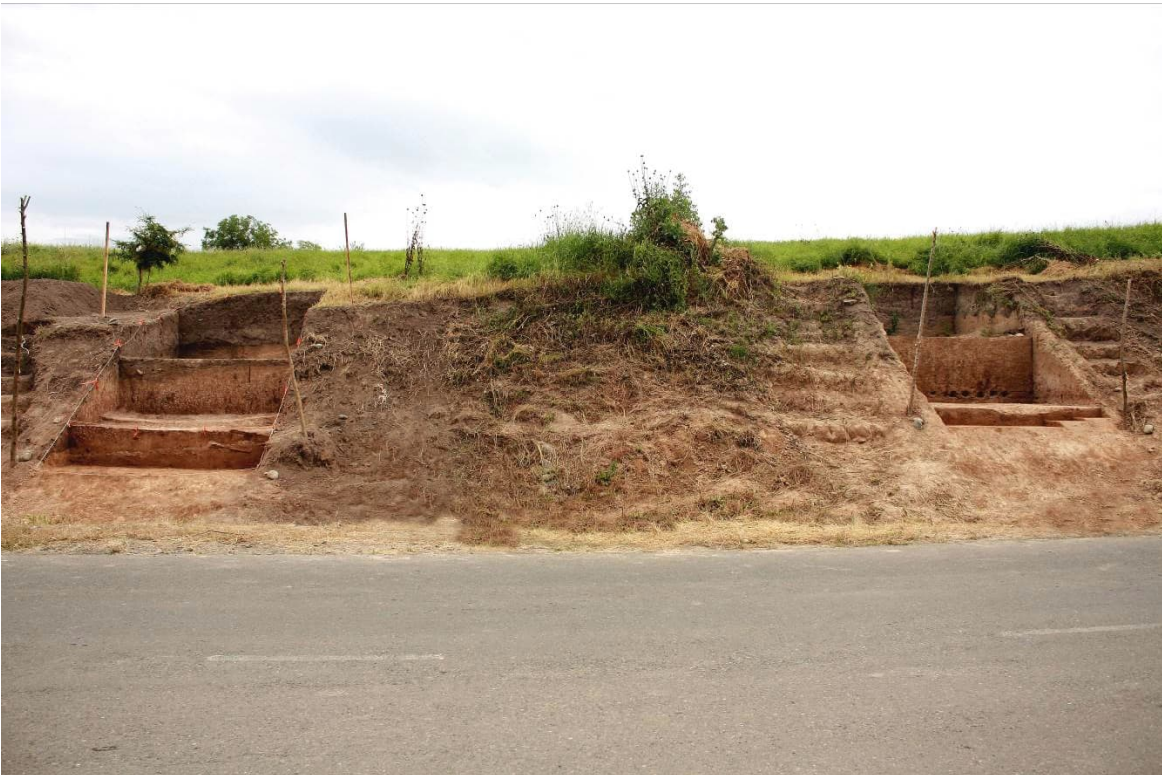
**Image 24.** The village of Bagratashen. Trenches, uncovered by the 2011 excavations of the Bagratashen-1 Middle Paleolithic open-air site

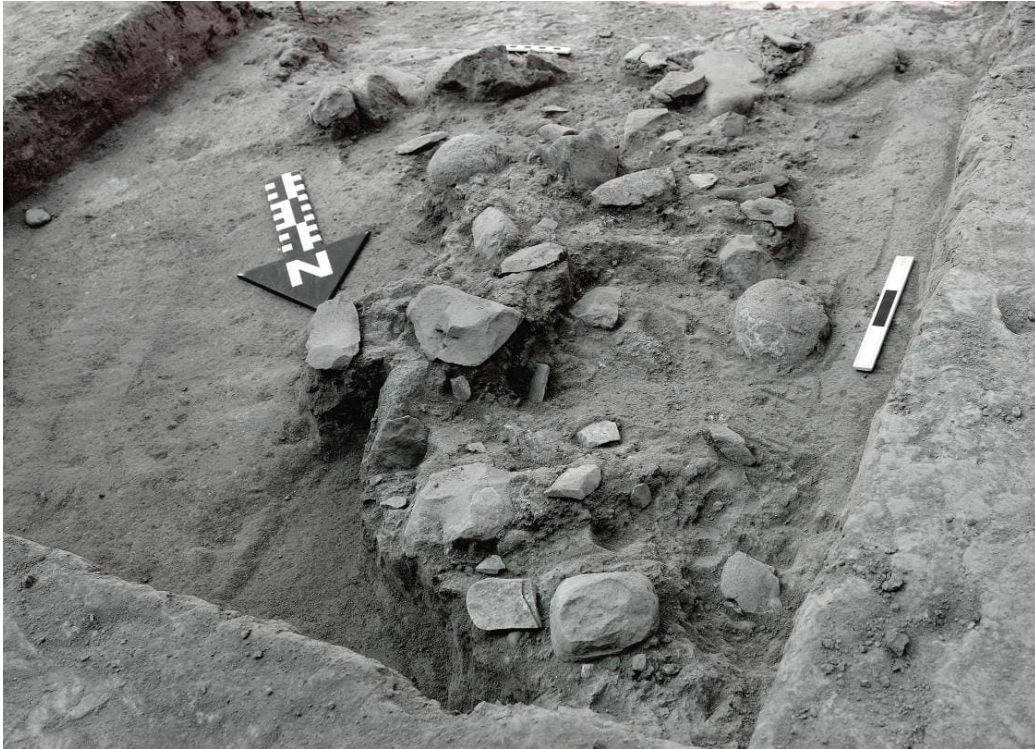
**Image 25.** The village of Bagratashen. Archaeological layer, uncovered during the 2011 excavations of the Bagratashen-1 Middle Paleolithic open-air site where the distribution of the stone artifacts is visible
